Naval Surface Warfare Center Carderock Division

CARDIVNSWC-61-TR-1999/13

Technical Report

Investigation of a Roof Tube Failure From a Utility Boiler

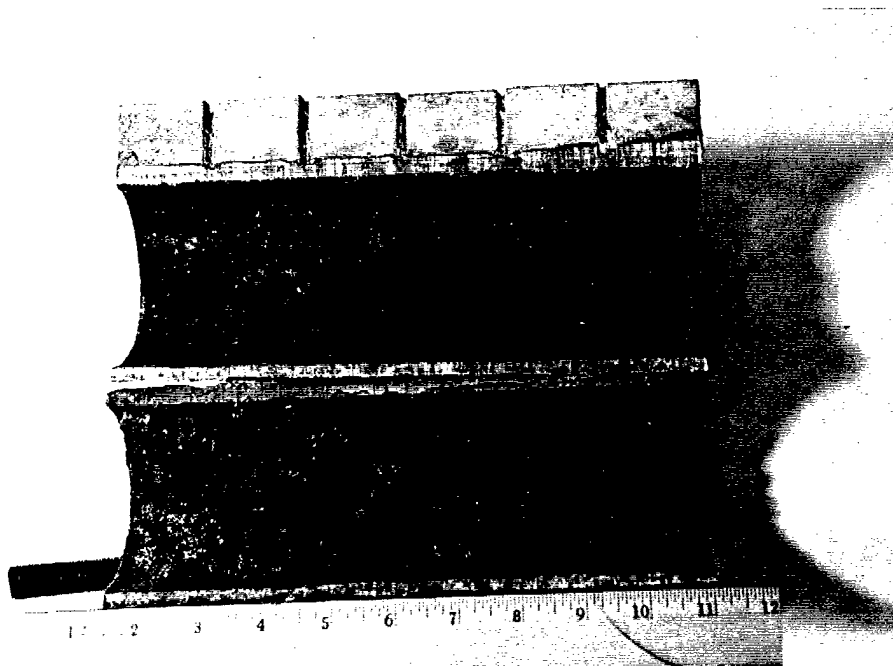
Figure 1 shows that the tube failure consisted of a one-inch longitudinal split along the hot side. This split coincided with local bulging of the tube at the hot side crown. The tube sample was cut along the longitudinal, membrane axis. Figure 2 shows that heavy deposits exist around the failure along the hot portion of the tube. A moderate amount of waterside deposition had occurred along the tube membranes; deposits were lowest along the cold portion (back side away from the flame). A side view of the respective waterside deposits (Figure 3) indicated that the hot deposit was one-inch thick in some places along the sample. The cold side deposit was approximately 0.020 inch thick near the tube membrane, while the deposit along the center of the cold side were less than 0.005 inch thick.

Figure 2 - Waterside surfaces of roof tube display heavy deposits on hot side (bottom tube half). Moderate deposits located at the tube membranes with lesser amount on the cold side.

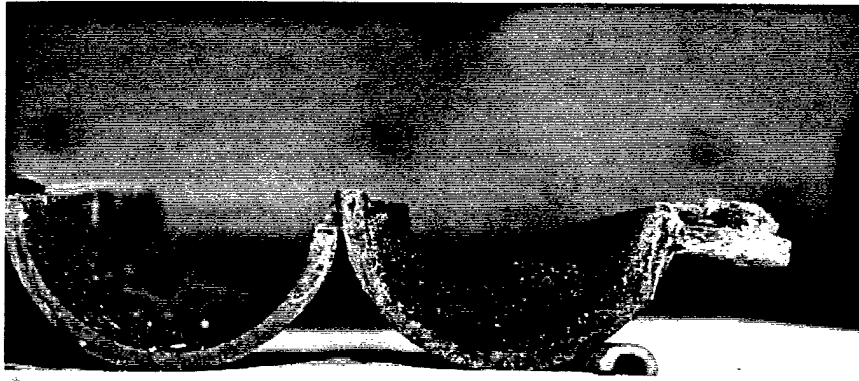
Figure 3 – Side view of tube sample reveals that hot side deposits are as much as 1.0 inch thick. Relatively little deposition was present on the cold side.

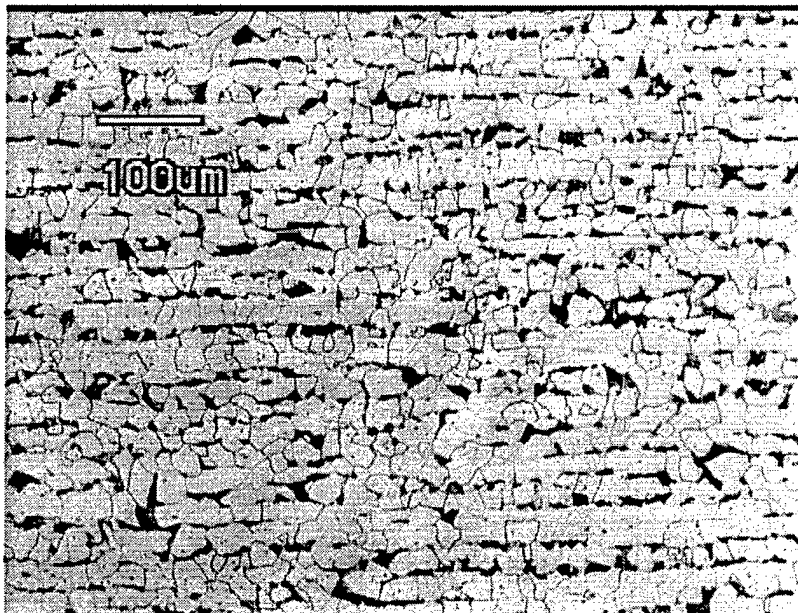
Specimens from the hot side and cold portions of the tube were selected for metallographic evaluation. The microstructure along the cold side (Figure 4) displayed a slightly banded configuration of ferrite and pearlite – a normal morphology of low carbon steel.

Figure 4 – Microstructure of the cold side displays a slightly banded ferrite morphology with pearlite. Magnification - 210X.

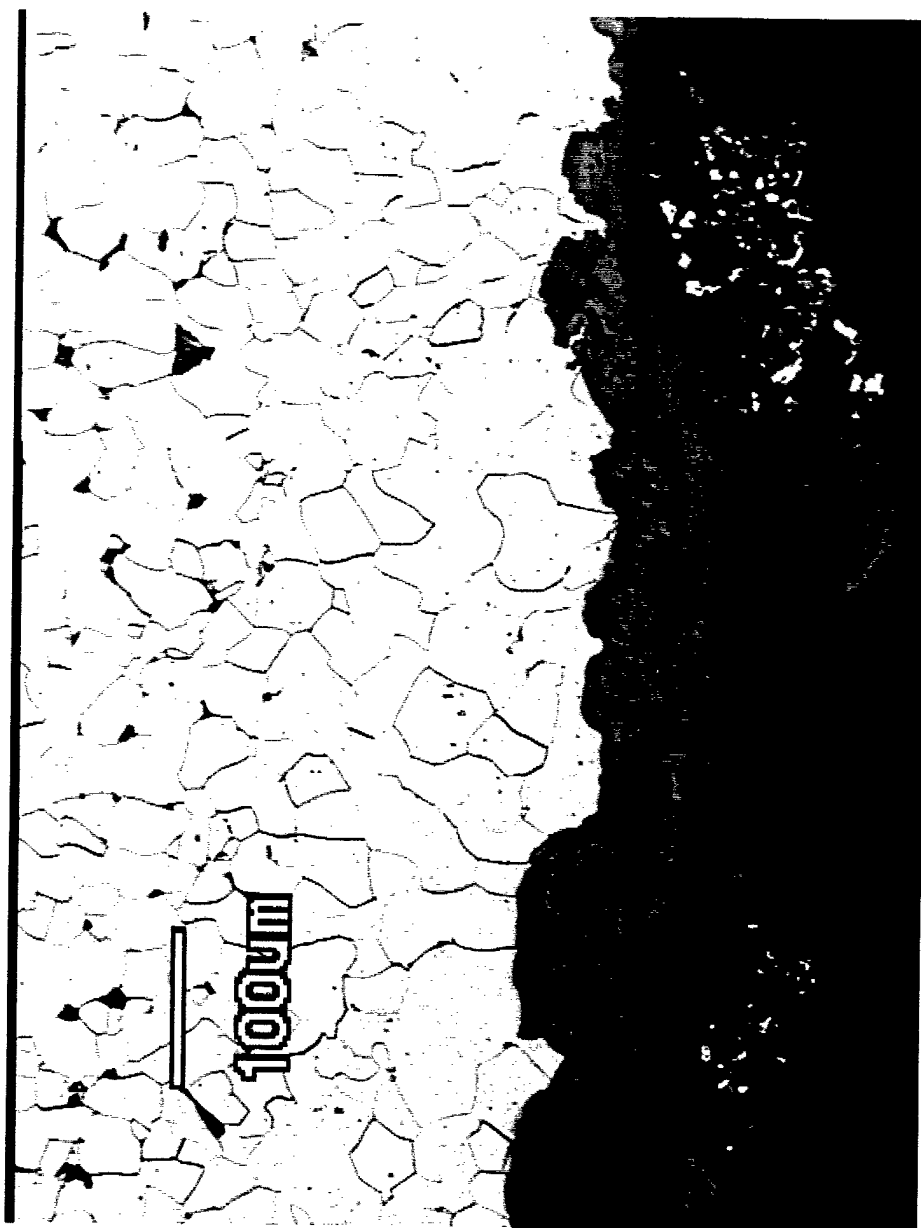
Figure 6 – Cold side oxide scale is about 0.004-0.006 inch thick, but tends to be porous. Copper metal is mixed in the deposit. Magnification - 210X.

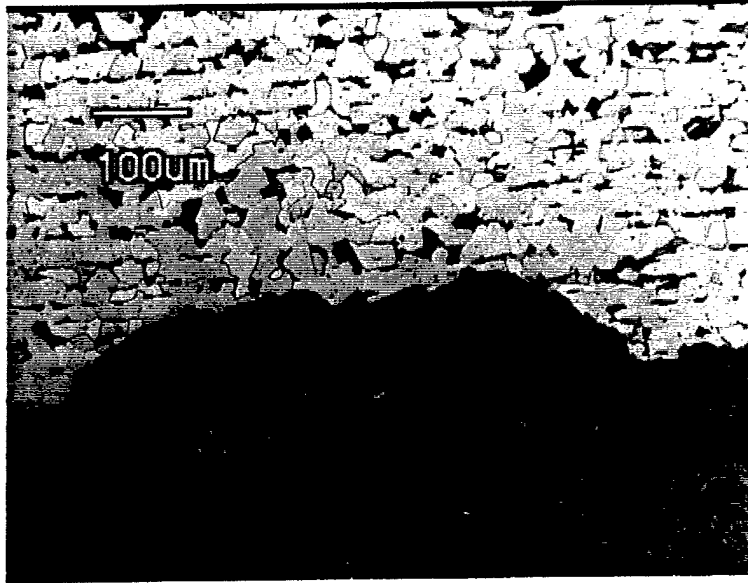
The microstructure along the hot side crown of the tube, but about 4 inches from the failure (Figure 7), discloses a relatively dense waterside deposit 0.001-0.002 inch thick with a more porous layer 0.003-0.011 inch thick. Copper metal particles are interspersed in the more porous layer. The tube substrate displays a matrix of pearlite and ferrite that shows no signs of thermal degradation as confirmed by the magnified photomicrograph in Figure 8.

Figure 7 – Microstructure along hot side crown displays a thick waterside deposit with some mixing of copper metal particles. The underlying tube matrix has not been overheated. Magnification - 210X.

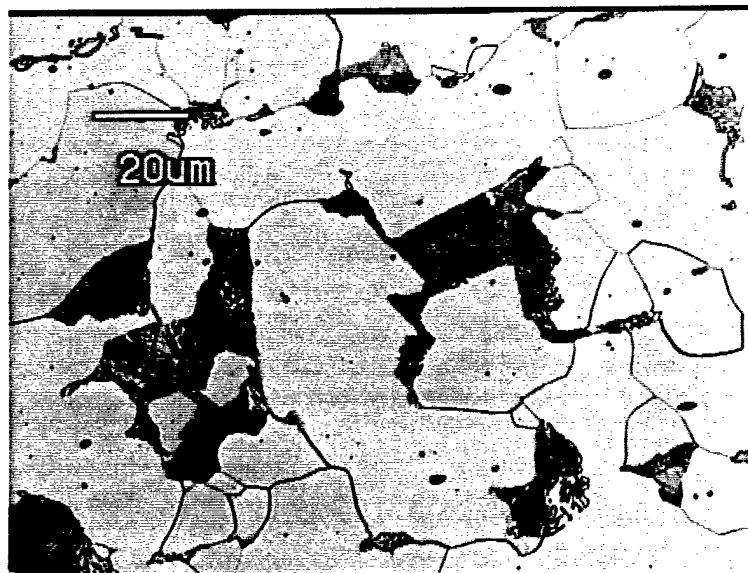
Figure 8 – Magnified view of Figure 7 shows no thermal degradation of the ferrite-pearlite tube matrix along the hot side area. Magnification - 1050X.

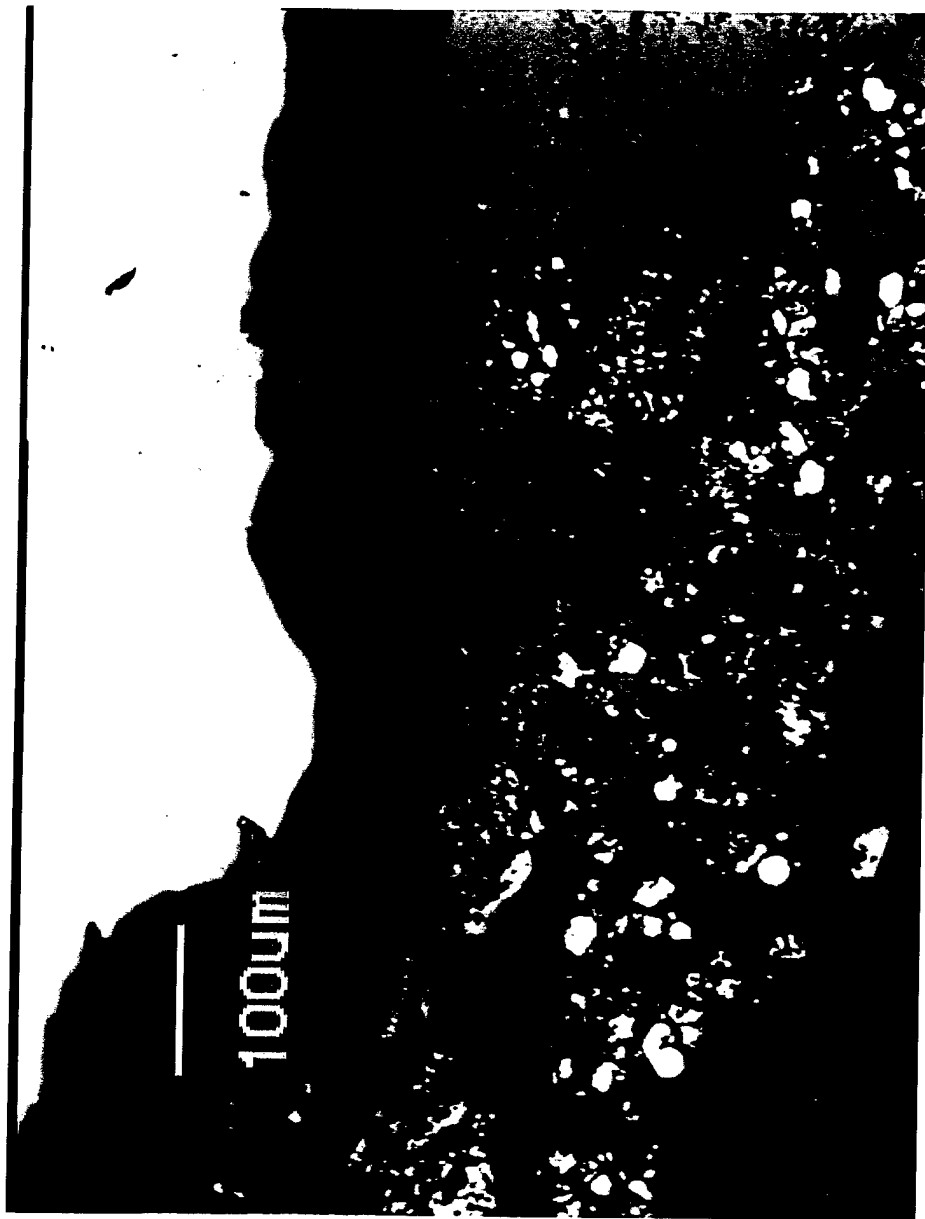
Figure 10 – Waterside deposit along hot side crown shows deposits containing mainly iron oxides, copper oxides, and copper metal. The high porosity of the thick deposit could provide opportunities for overheating. Magnification - 210X.

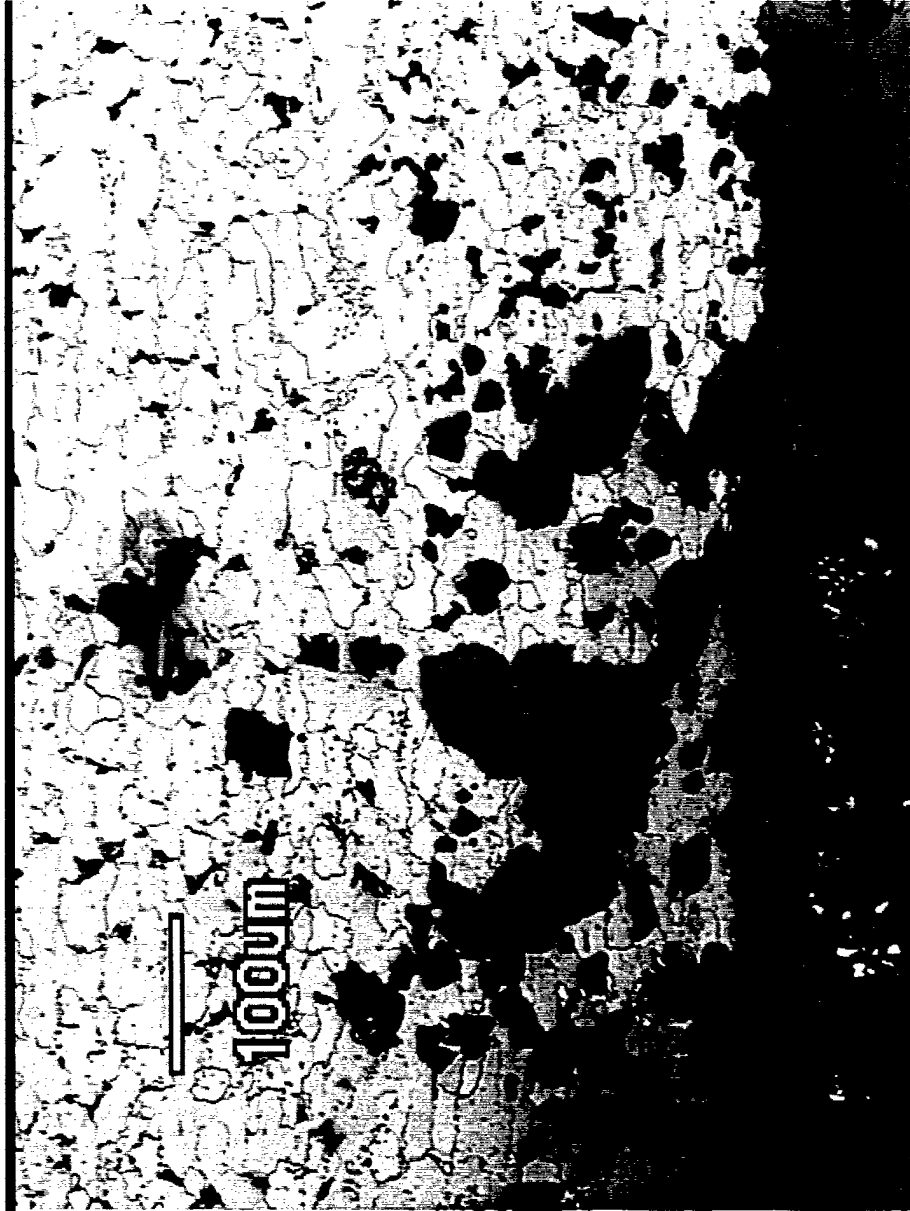
In Figure 11, the tube microstructure near the failure (~ 0.5 inch away) displayed complete spheroidization of the carbides from overheating. Voids developed at grain boundaries, particularly at three-grain junctions; these voids tend to be oriented perpendicular to the tube surface. The formation of these voids is due to long-term overheating and creep rupture. Some of the voids have grown and coalesced into larger voids and incipient microcracks; some of the largest voids have formed surface oxides. There is slight elongation of the grains as a result of tube swelling and expansion. The photomicrograph (Figure 12) shows a magnified view that clearly shows that the carbides at former pearlite colonies have fully spheroidized. Some of these carbides have dispersed into the grains. Other random carbides are present along the grain boundaries; , voids have formed at some of these grain

Figure 11 – Waterside surface, hot side, near failure. Carbides in prior pearlite colonies have completely spheroidized from overheating. Creep voids have developed at grain boundaries; some of these voids have grown and coalesced. Magnification - 210X.

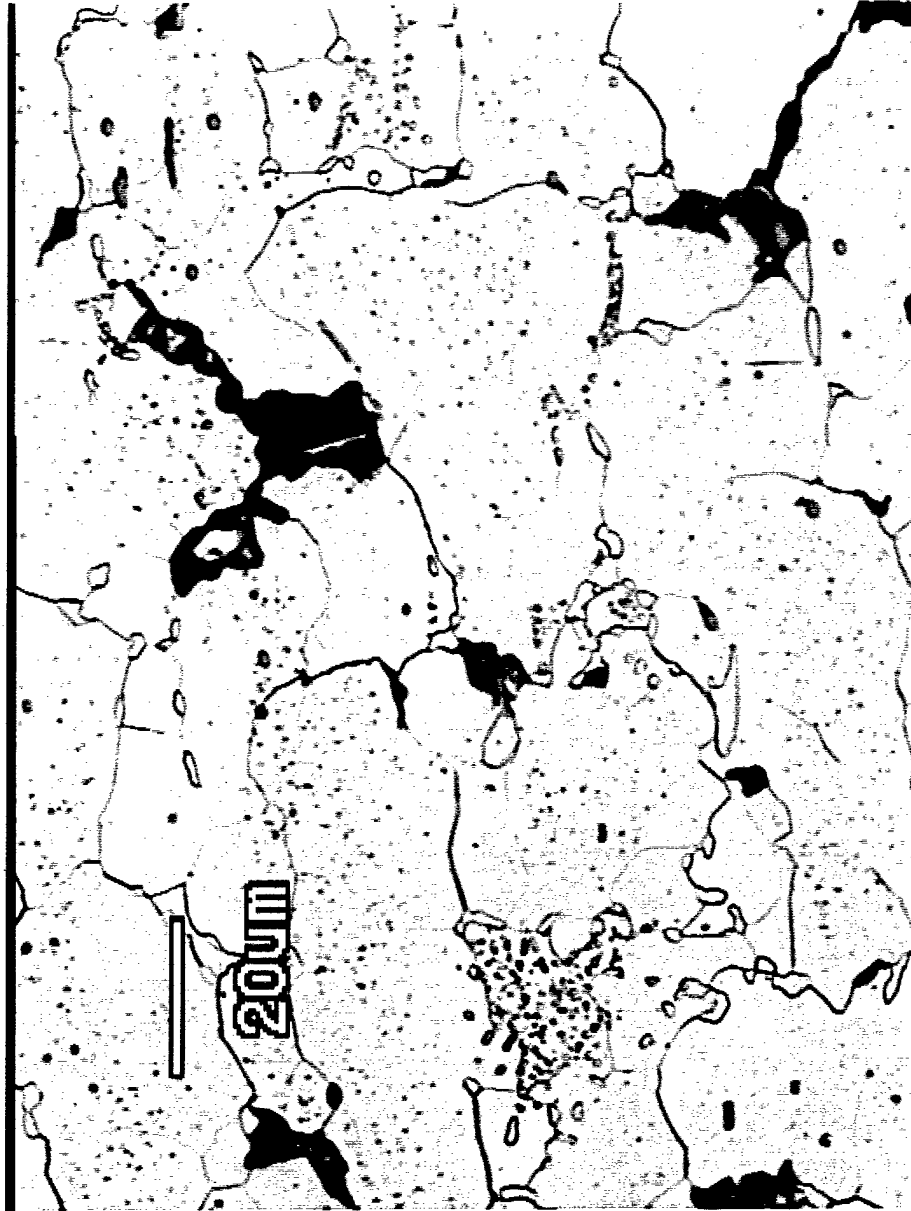
Figure 12 – Carbides are fully spheroidized from thermal degradation near failure. Voids (dark sites) have formed along the grain boundaries that are perpendicular to the direction of applied stress. Magnification - 1050X.

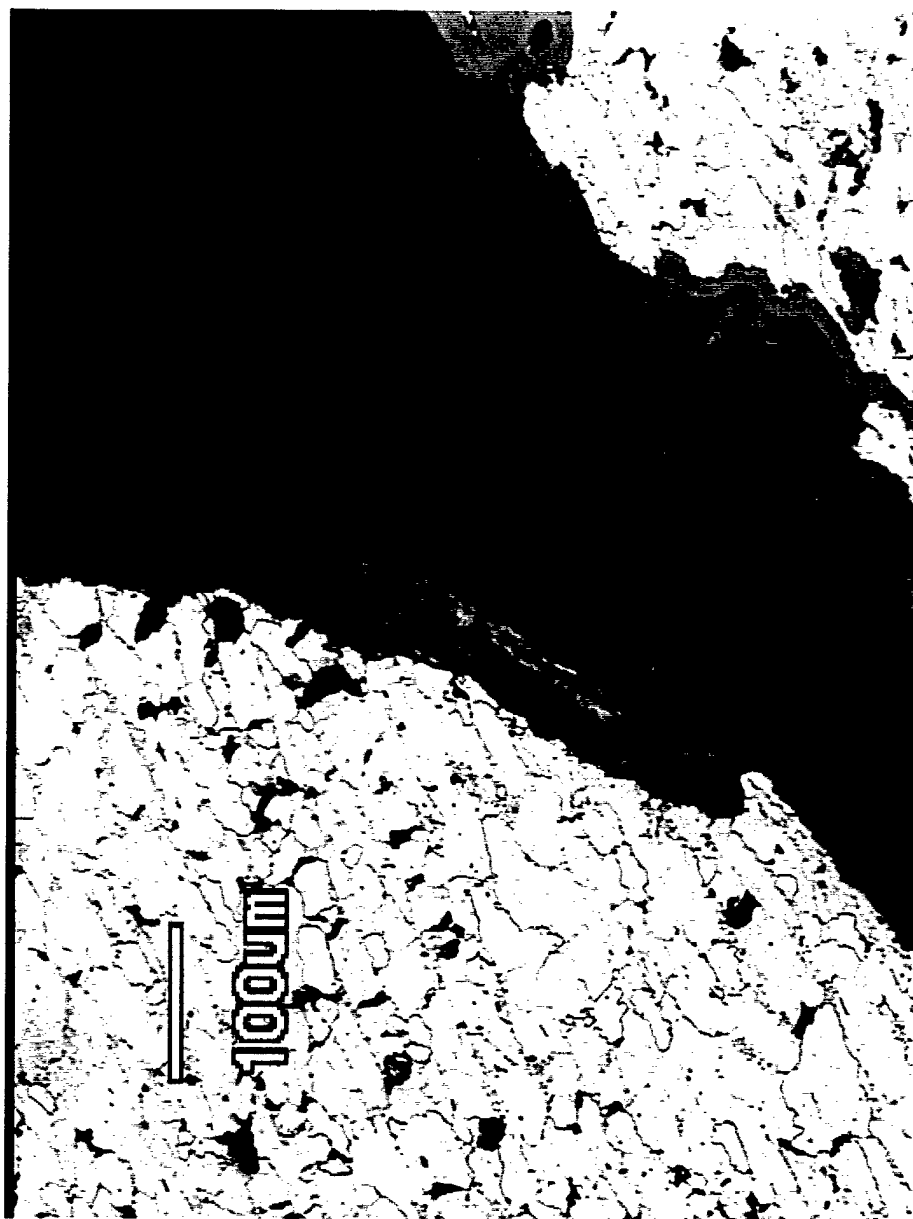
Voids initially formed at three-point grain boundaries, grew, and coalesced to form larger voids and microcracks. A few of these microcracks grew in the areas of highest stress to form macrocracks. Formation of these macrocracks increased the local applied stress, causing the cracks to grow with time. Figure 13 shows the macrocrack that led to a through-wall failure. The fracture surface is covered with a heavy oxide scale which appears to indicate that crack propagation occurred over a relatively long time. Some copper from the waterside surface has become embedded in the oxide scale.

Figure 13 - Fracture surfaces near tube midwall. The fracture surfaces are covered with a heavy oxide scale. Copper metal has been transported to this site. Creep voids found in the tube matrix along the fracture. Magnification - 210X.
